## DEBRIS FLOWS IN MOZI GULLY, CHINA FOLLOWING THE 2008 WENCHUAN EARTHQUAKE

### ABSTRACT

**KEY WORDS:** Mozi gully, Wenchuan earthquake, debris flow, landslide, landslide dam

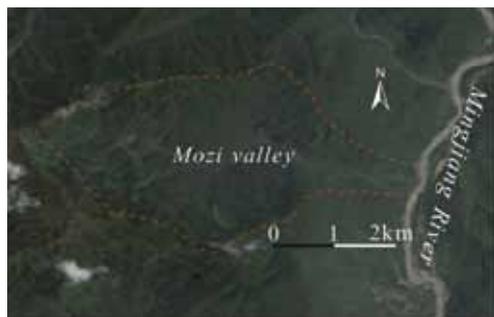
Fig. 6 - Remote image of Mozi gully from June 26, 2008 (Before the Wenchuan earthquake)

A comparison of satellite remote imagery taken before and after the Wenchuan earthquake, indicates that the landscape of the Mozi valley has been significantly altered by the earthquake (Fig. 6 and 7). The scars left by landslides, avalanches, and rockfalls triggered by the earthquake occupy approximately 73.2 percent of the valley area. Almost all of the channels are filled with sediment, and some are blocked by the deposits of particularly large failures (Fig. 7). Field surveys in December 2008 and May and July 2009 and aerial photo interpretation identified up to eight large landslide dams in the valley, the largest of which is estimated to contain  $7.8 \times 10^5$  m<sup>3</sup> of material (Tab. 1, Figg.8 and 9).

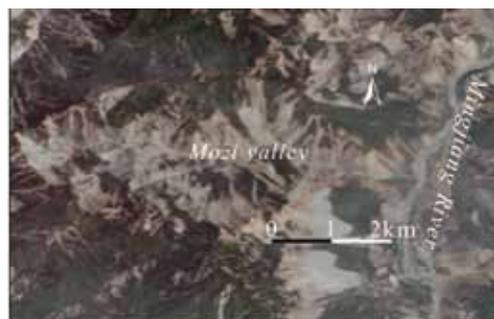
Fig. 7 - Remote image of Mozi gully from June 3, 2008 (after the Wenchuan earthquake)

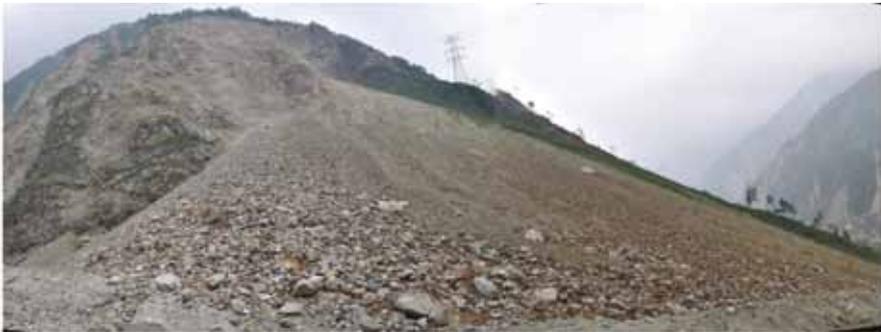
Fig. 9 - Photograph of a landslide collapse on the left bank of Mozi gully (2009.7.5)

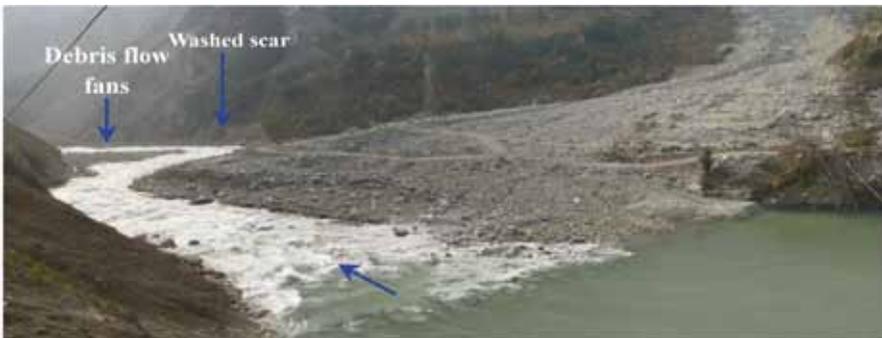
Fig. 10 - Photograph showing the Mingjiang River partially blocked by debris flow from Mozi gully, 2008 (Photograph taken in (December, 2008) The river was completely blocked for only 15 minutes)

on July 14<sup>th</sup>, 2008 when the river was completely blocked for 15 minutes (Fig. 10). According to the Dujiangyang weather station (located 15 km from Mozi gully), between July 1 and September 30, 2008, 605.8 mm of rain fell over a seven day period, with intensities greater than 25 mm/24 h. The largest daily accumulation was 91.9 mm, which occurred over 24 hours on September 23, 2008. Storms on July 14 dropped 70.1

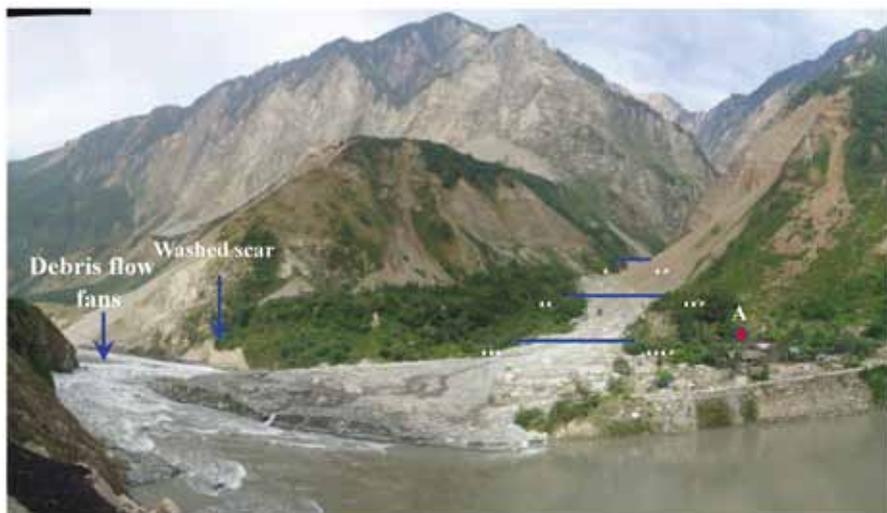
Fig. 13 - Photograph showing Mingjiang River blocked by debris flow from Mozi gully in 2009 (front edge of deposits have been removed). Photograph taken on July, 2009

On August 17, 2009, debris flows travelled out of Mozi gully and buried about 500 m of the National 213 highway, and the existing V-shaped channel was turned into the U-shaped (Fig. 13, 14, 15, 16 and 17). The deposits from these debris flows formed a mound with an average thickness of 20 m and width of 400 m, giving an estimated volume of  $9 \times 10^5 \text{ m}^3$ . The density of the debris flow measured from samples of the deposits was  $1.95 \text{ g/cm}^3$ . With this high value, the debris flows are expected to be highly viscous and move as a series of surges, as reported by eye-witnesses.

As for the discharge, we have measured three cross-sections in the valley (Fig. 13, 20, 21 and 22), with parameters listed in Table 2. Those cross-sections are used to estimate a peak discharge of the debris flow.

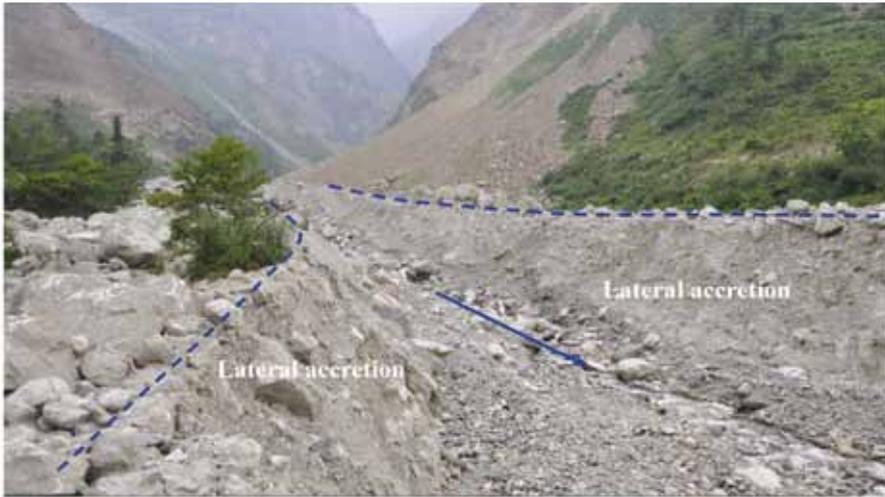
Fig. 14 - Debris flow deposits in downstream reach of Mozi gully

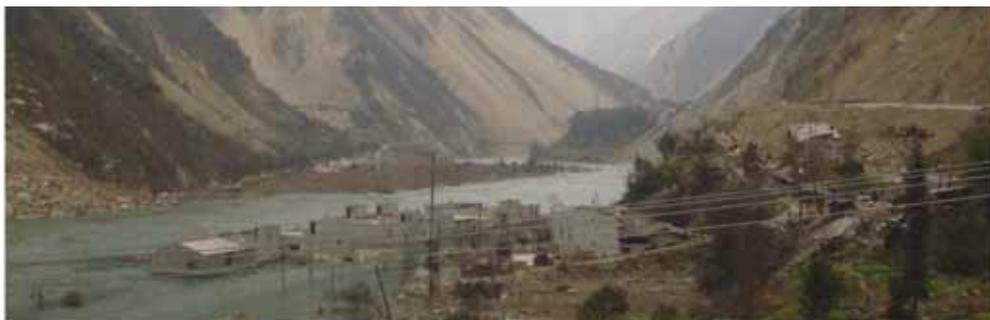
Fig. 18 - Submerged houses in lake upstream from landslide dam at confluence of Mozi gully and the Mingjiang River in December of 2008

In this event, debris flows generated from Mozi gully completely blocked the Mingjiang River, forming a dam. The dammed water rose 15 m above the streambed and inundated a village located 3 km upstream from the confluence of Mozi gully and the river (Fig. 18). In December of 2008 the water was 8 m deep and the backwater extended 1 km upstream (Fig. 19).

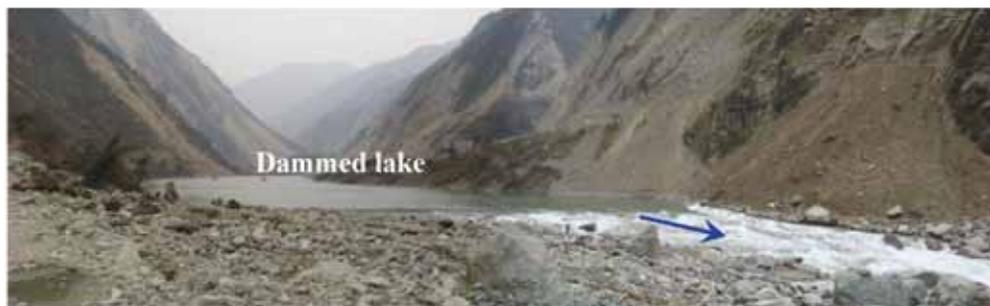
Fig. 19 - Lake formed by landslide dam at confluence of Mozi gully and the Mingjiang River in December, 2008. Blue arrow indicates direction of flow
