## TECHNICAL AND HUMAN ASPECTS OF HISTORIC ROCKSLIDE DAMMED LAKES AND LANDSLIDE DAM BREACHES

CH. BONNARD

Soil Mechanics Laboratory, Swiss Federal Institute of Technology, Lausanne, Switzerland EPFL-ENAC-ICARE-LMS, Station 18, CH-1015 Lausanne

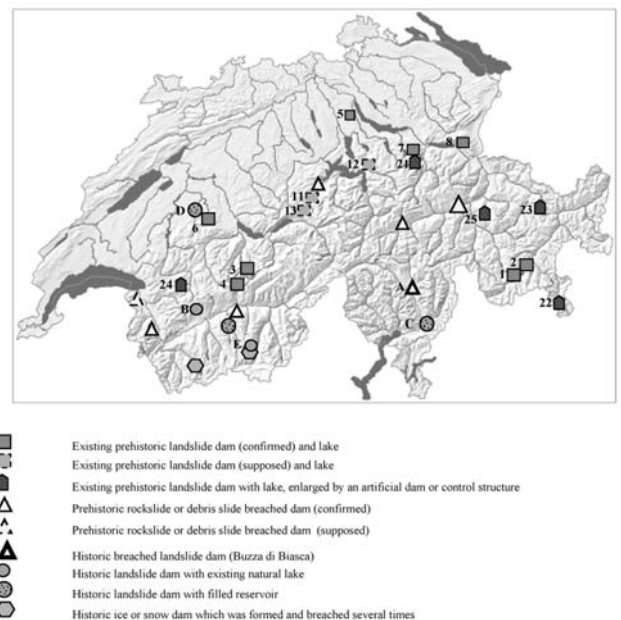
Figure 1 - Map of landslide dams in Switzerland (the cases presented in the following text are marked by letters A-E; see the names of numbered cases in Table 1)

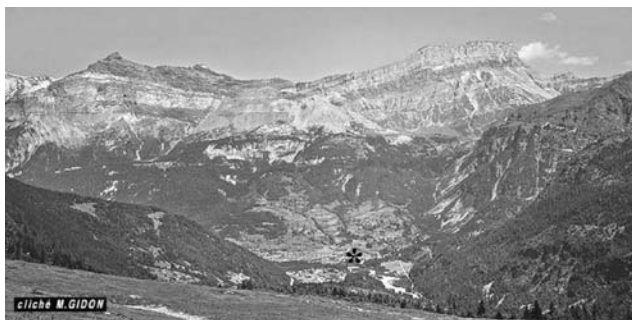
Figure 2 - Perspective view on the slides affecting the slopes of the Massif of Platé. The village of Servoz is shown by a star

One of the most ancient reported cases originates below the limestone Massif of Platé, near the Mont-Blanc, some 1500 m above the Arve river (Figure 2). During the early Christian era a large slide mass blocked the gorge of the Arve, an affluent of the Rhone river, impounding a lake which overflowed, not into the original gorge, but into a parallel gorge of Le Châtelard, some 500 m to the south. The lake seems to have persisted until the XIII century, that is more or less 1000 years, which can be justified by the fact that the initial overflow did not occur on the slide mass itself. The failure of the landslide dam finally reestablished the old course of the river.

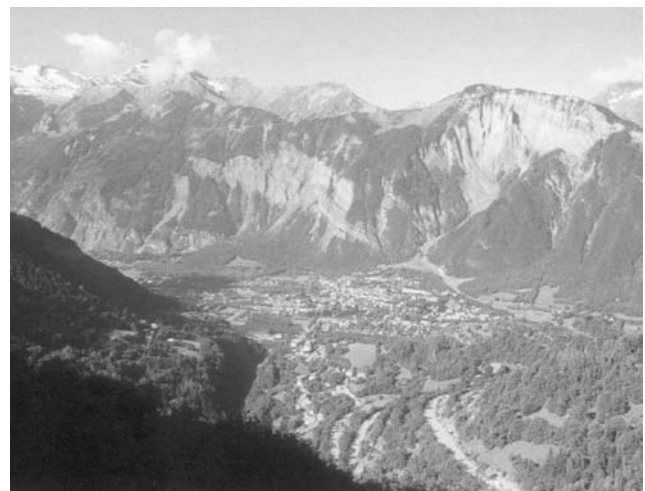
Figure 3 - View of Bourg d'Oisans in Romanche valley

turies, the lake bed was progressively filled with sediments and became a swampy area along a channelized river course. In the XIX century drainage ditches allowed the plain to become a fertile agricultural land and later the town to extend (Figure 3).

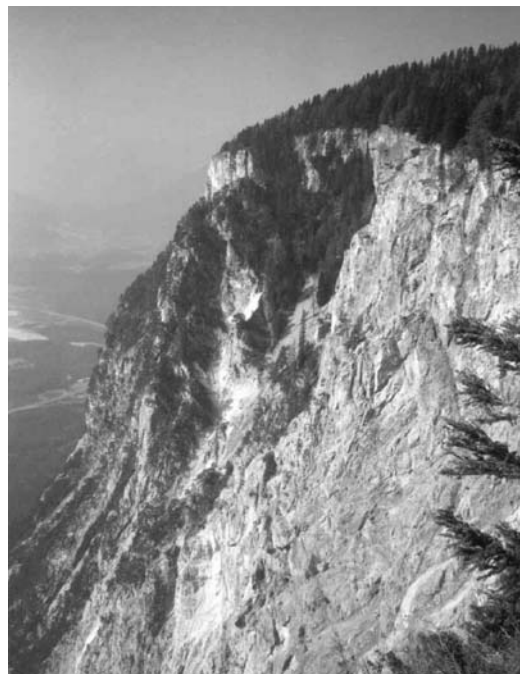
Figure 4 - View of the top scarp of Dobratsch rockslide. Large fissures can be seen in the forest on the top

On January 25, 1348 a significant earthquake shook the Dobratsch massif (El. 2000 m) and caused large rockslides, one of which, approx.  $30 \times 10^6 \text{ m}^3$  in volume, along a fault surface dipping  $45^\circ$  to the south, blocked the 2.5 km wide Gail valley (El. 500 m) (Figure 4). This valley, which corresponds to a major Alpine fault (Periadriatic Lineament) had already been affected by several rockfalls at the end of the last glaciation following the erosion of the toe of the north side of the valley. Several settlements were buried by the rockfall and flooded upstream, and a short time later the dammed lake burst across the dam and devastated the valley below. Presently the hydraulic head created by the remaining debris lobe is used in a hydroelectric scheme and villages are developing in the valley despite of risks related to the presence of large sinkholes and fissures behind the highest Dobratsch cliff face.

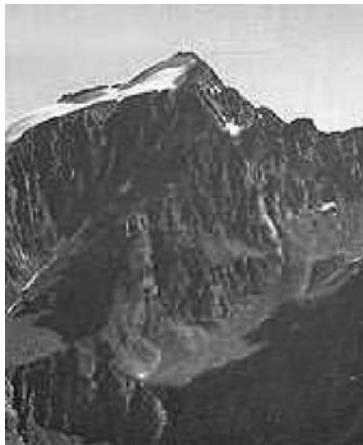
Figure 6 - View of Pizzo Magno from which the rockslide started

On September 30, 1513 a large rockslide 10 to 20x10<sup>6</sup> m<sup>3</sup> collapsed from the north-western steep slope of Pizzo Magno (El. 2329 m) (Figure 6 and case A in Figure 1) and blocked the Blenio Valley at El. 400 m, just upstream of the town of Biasca where the Ticino River and Brenno river (flowing in Val Blenio) merge. This landslide dam called Buzza di Biasca (BONNARD, 2004) first destroyed several buildings down to the outskirts of Biasca, then created a lake extending 5 km upstream, which reached a volume of 100x10<sup>6</sup> m<sup>3</sup> and drowned the communities of Malvaglia and Semione. During nearly 20 months, this lake, first well observed, seemed to have become a permanent feature of the valley. But on May 20, 1515, a few months before the battle of Marignan, the spring time overflow eroded the dam, causing its collapse. The city of Biasca was swept away as well as the valley of the Ticino down to Bellinzona (a main fortified town) and then to Lago Maggiore, so that 600 persons died.

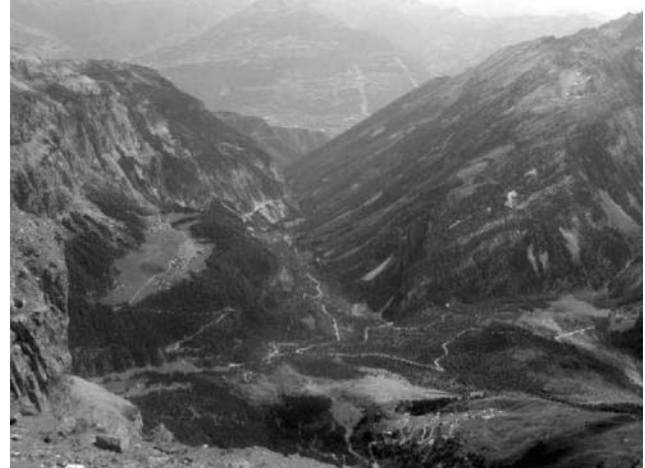
Figure 7 - Lower part of Derborence rockslide as seen for Les Diablerets mountain. The major lake is visible on the right side of the photo

and moved over a total distance of 5 km, creating the lake of Derborence at the outlet of a nearby creek called the Derbonne, the lake of Godey in another creek, which has been raised by a dam built just on the side of the landslide mass, as well as three small lakes just on the side of the landslide mass itself which still exist (GABUS, 1990). The total landslide mass has been assessed by HEIM (1932) at 50x10<sup>6</sup> m<sup>3</sup>. Smaller rockfall events still occurred later but without major impact. The main natural lake, still existing today, is now nearly filled with sediments and its depth does not exceed 3 m so that it does not represent a threat anymore (Figure 7).

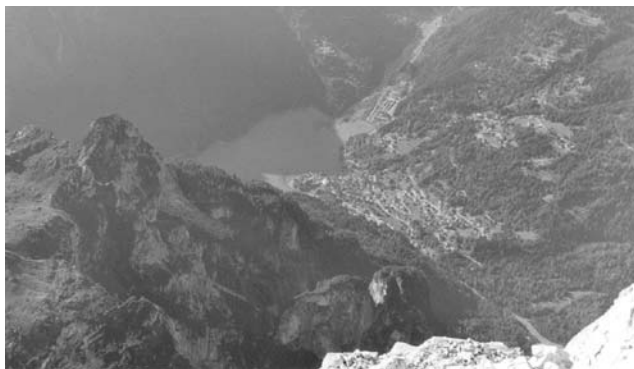
Figure 8 - Lake of Alleghe with developing vacation resort on the landslide dam

Some years later, in 1771, not very far from the recent Vaiont disaster, at the limit of the Southern Alps, a dip slope rockslide of some 20 x 10<sup>6</sup> m<sup>3</sup> blocked the Cordèvole valley, climbing more than 50 m up the opposite slope, destroying three hamlets and killing its 49 inhabitants. With the formation of the lake of Alleghe, 5 hamlets were drowned upstream, as the lake extended over some 4 km. On May 1, 1771, a part of the main scarp cliff fell and plunged into the lake from a height of 1000 m causing a wave that surged over the opposite slope and up a lateral valley formed by the Zunaina Torrent. In the nearby village of Alleghe, it damaged the church and killed three people. Happily the rockslide dam was not affected by the wave; it was reinforced later to provide a stone masonry and concrete lining. As in the precedent case, the sediments of Cordèvole Torrent are progressively filling the lake, the depth of which has decreased from 50 m to 15 m. Despite of residual risks of rockfall, the area of the dam has been developed as a vacation resort (Figure 8).

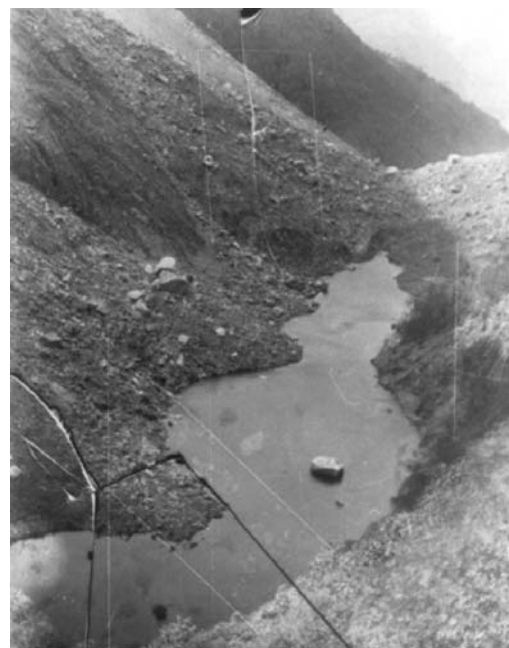
Figure 10 -View of Motto d'Arbino rockfall dam in Arbedo valley, taken just after the event, in 1928

The first one refers to Motto d'Arbino rockfall, located some 20 km South of the Buzza di Biasca (see above), which occurred in October 1928, when 30 to 40x10<sup>6</sup> m<sup>3</sup> of rock blocked the valley of Arbedo causing a small lake 1.5 km long (Figure 10 and case C in Figure 1). Despite of several debris flows which reached the village of Arbedo downstream, the gorge formed by the Traversagna torrent was not eroded. Between 1930 and 1950 a 30 m high debris retention dam was built so that the lake is now totally filled with sediments and the former debris course has been occupied by residential buildings. The most interesting aspect of this case is that, since 1925, a routine triangulation survey on Motto d'Arbino monument at the top of the mountain showed a clear preparatory movement, which was monitored in detail in 1927 and 1928, supplying the first scientific and duly measured evidence of the acceleration phase before the rockfall (ENGEL, 1986), allowing the evacuation of the 16 houses that were demolished by the rockfall.

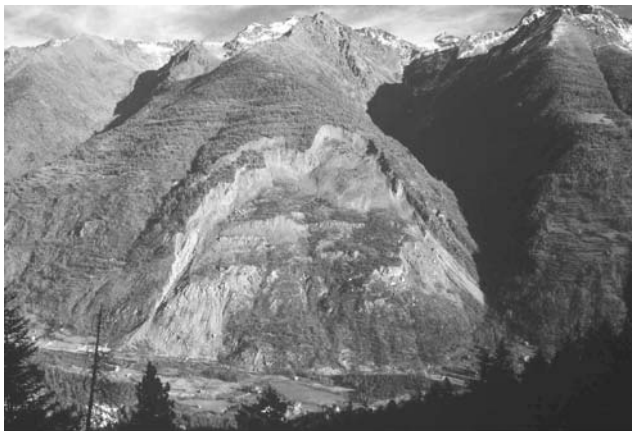
Figure 11 - Recent photo of La Clapière rockslide which permanently threatens the Tinée valley, north of Nice

For the second case, La Clapière rockslide in the South of the French Alps, near the Italian border, the slope movement caused by a large toppling mechanism was first reported in 1976, but despite of several critical periods of acceleration, in particular in 1987 and 2001 (DURVILLE, pers. comm.; PILOT & DURVILLE, 1990), the landslide mass displaced the river bed of the Tinée river towards the west, but never dammed it effectively (Figure 11).

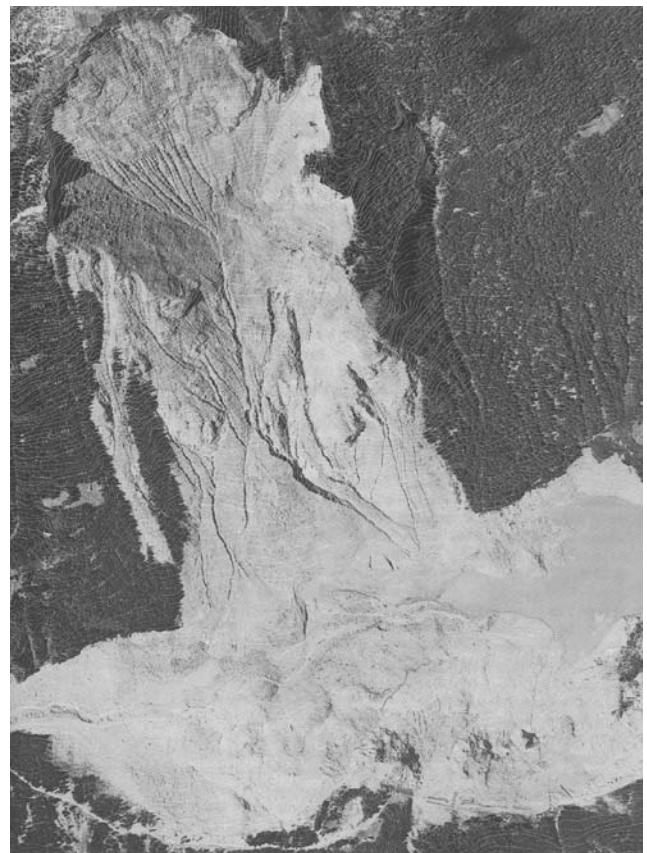
Figure 12 - Air view of Monte Zandila rockslide mass in the Valtellina valley. The formed lake is visible on the right

The third case, in Valtellina valley in the North of Italy, deserves mentioning for two reasons. First it is a dramatic example of a two-phase landslide: a first debris flow originating in the adjacent Val Pola, following the extraordinary rainfall of July 18 and 19, 1987, dammed the Adda valley and increased the height of an existing small lake. A week later, as a long crack appeared in the slope of Monte Zandila and frequent rock blocks fell below this crack, four villages upstream were evacuated. But on July 28, at 7.23 in the morning, a huge rockslide (approx.  $40 \times 10^6 \text{ m}^3$ ) occurred, fell in the valley mainly downstream of the lake the level of which had increased and went up the opposite slope some 300 m above the valley floor; the upstream part of the mass fell directly in the lake, causing a 95 m high wave of water and debris which moved more than 2 km upstream, provoking the destruction of two villages which had not been evacuated initially and therefore the death of 27 persons (Govi, 1990) (Figure 12).

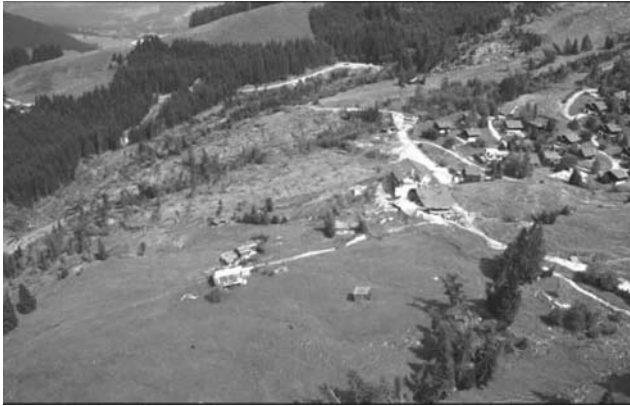
Figure 13 -Lower part of Chlöwena landslide and destroyed Falli Hölli village. The lower part of the slide evolved in a mudslide to form a dam in the nearby river

The last recent case worthwhile reporting occurred in August 1994, due to Chlöwena landslide (VULLIET & BONNARD, 1996) which dammed the Höllbach Torrent, not far from the City of Freiburg, after a progressive acceleration phase which lasted at least four months (Figure 13 and case D in Figure 1). Even though the lake was of very limited volume, the risk was high as the dam height nearly reached 40 m, as the torrent was known to experience violent floods (hence his name: Höllbach, i.e. Hell Torrent) and as there were several industrial plants along the river downstream in the town of Marly. Due to the progressive movement of the slide (a maximum displacement 250 m was recorded) and creation of the dam, time was allowed for the computation of the formation of the dam with a viscous mechanical model and for the execution of hydraulic model tests to check the overflow conditions. Finally the flow found its way along the edge of the landslide mass without causing any damage up to now.

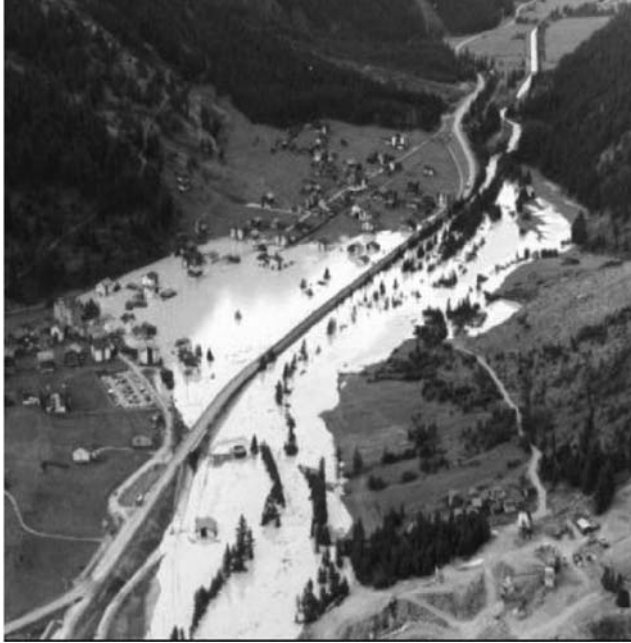
Figure 15 - Due to a debris flow which blocked the provisional excavation channel, the plain below Randa village was flooded for a short while. The road could be maintained thanks to a floating bridge set up by the Swiss Army

These comprehensive mitigation actions, combined with the construction of a provisional channel, limited the flooding of the lower part of Randa Village: only at two occasions, after intense storms, the village was partially under water; in particular, on the second occasion, the main cause was the plugging of the diversion channel by a debris flow coming from the Dorfbach, facing Randa rockfall (Figure 15).

Later on, a 3 km long diversion tunnel was built in the left bank to avoid flooding, so that no catastrophic dam breach occurred. But the sewage plant used for Randa and the upstream villages, located along the river, was completely flooded during the year 1991, which caused additional environmental impacts (see lower part of Figure 15).

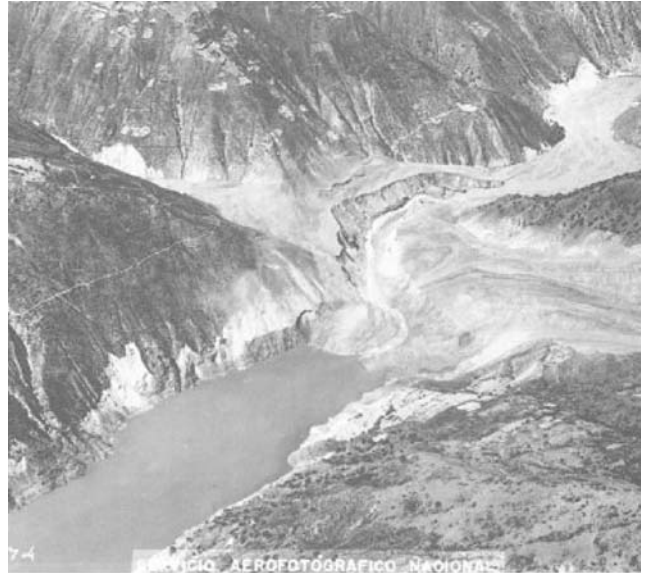
Figure 16 - Aerial view of Mayunmarca landslide dam (from Servicio Aerofotográfico Nacional del Perú)

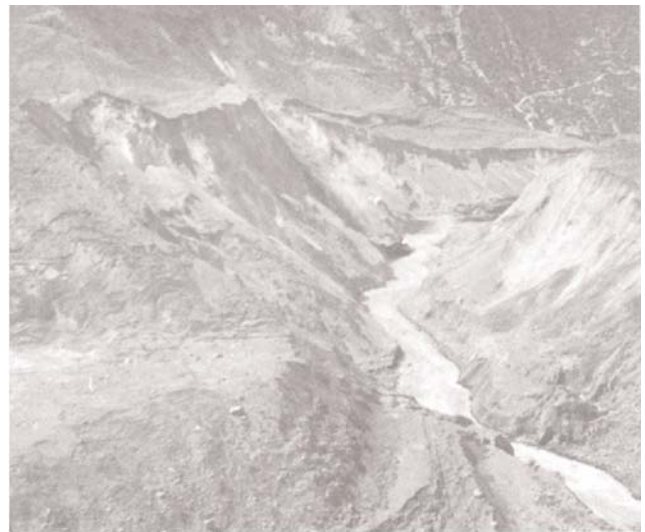
Figure 17 - Erosion gorge in Mayunmarca landslide dam after the outflow, more than 100 m deep

The lake was rapidly filled to El. 2625 m reaching a volume of  $670 \times 10^6$  m<sup>3</sup> and extending about 30 km upstream from the natural dam. 44 days after the rockslide, on June 8, 1974, it breached (Figure 16); the flow passed first, during the previous day, through a shallow channel up to 3 m deep, which had been excavated by bulldozer over a length of 250 m. The maximum discharge can be assessed between 7000 and 15000 m<sup>3</sup>/s, which eroded a deep gorge whose longitudinal profile had an inclination of not more than 1.5° (Figure 17).

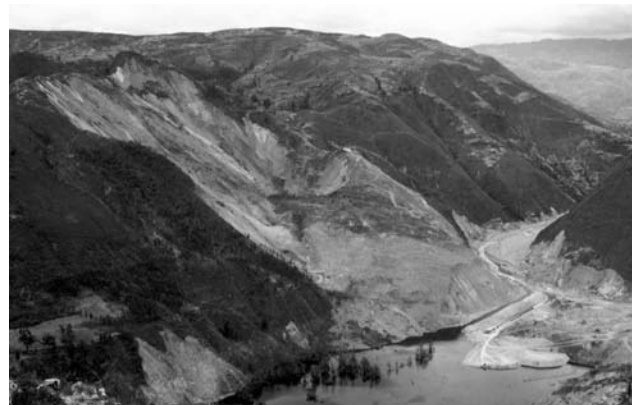
Figure 18 - View of La Josefina landslide dam, some months after breaching. A deeper artificial channel is excavated to decrease the level of the residual lake

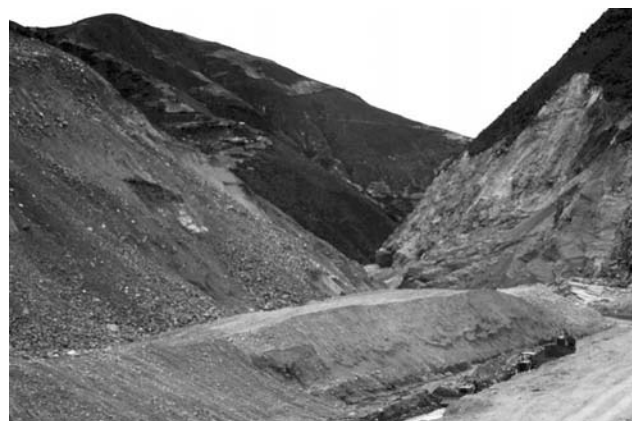
Figure 19 - Excavation of a new channel in the landslide mass after the May 1<sup>st</sup>, 1993 overflow. The unstable left slope that needed a stabilizing scheme can be observed

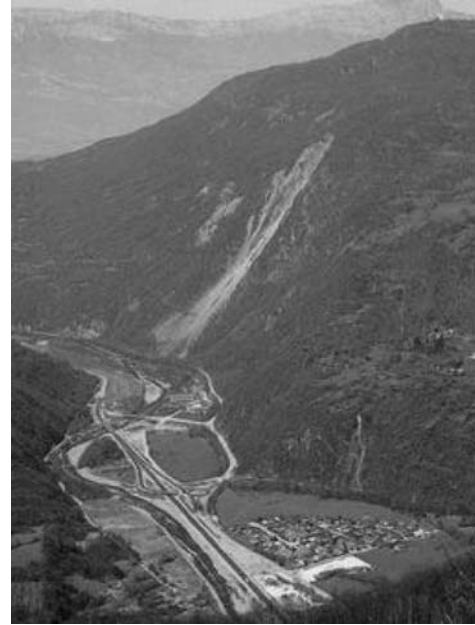
Figure 20 - Zone of impact of Séchilienne rockfall
